Manhole Inspection Summary

Manhole # S31II2045MH

Location Address: **6304 MOSSWAY**

Manhole Type: **Diversion** Location: **Grass**

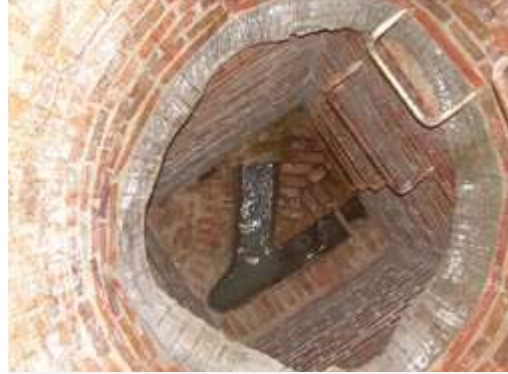
Top View

Evidence of surcharge - Bench debris.

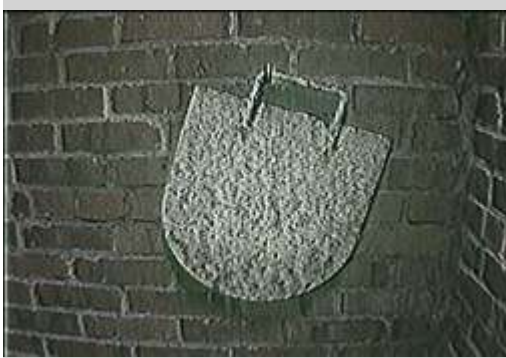
Additional metal plate

Additional metal plate, not sure there is a pipe behind it

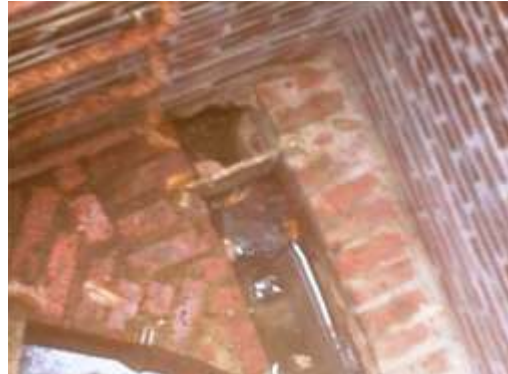
Diversion structure

Comments **Unable to take measurments - this is an out pipe; however there is a metal plate (a diversion structure) that is in front of the out pipe. This structure is preventing us from taking measurments.**

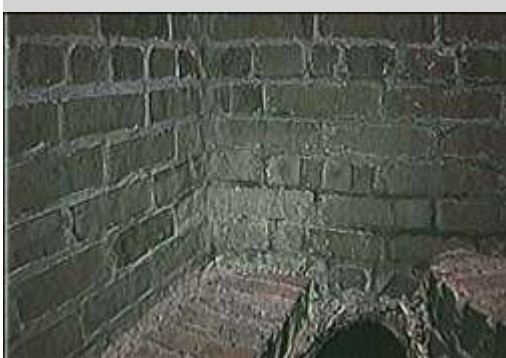
Defect

Barrel infiltration.

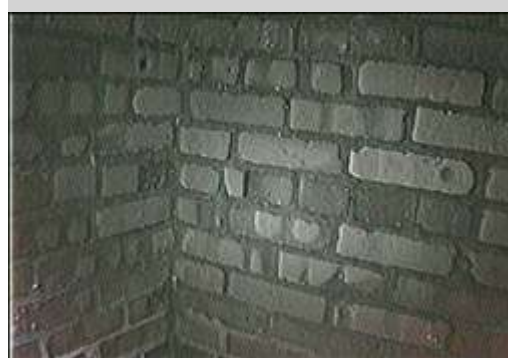
Defect

Barrel infiltration.

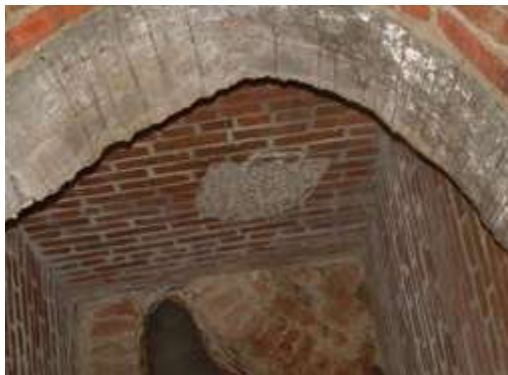
Defect

Adjustment, Corbel and Barrel infiltration.

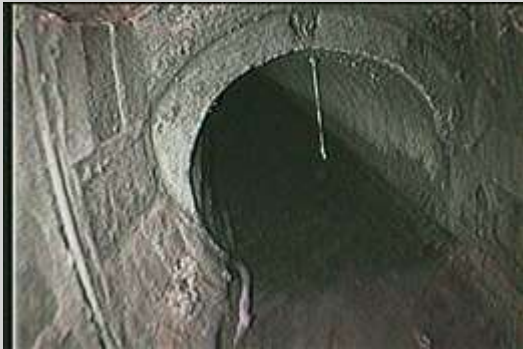
12 in. Circular Gravity Sewer Pipe Out @ 12 O'Clock

Infiltration: **Evidence** Pipe Seal Cond: **Unknown**

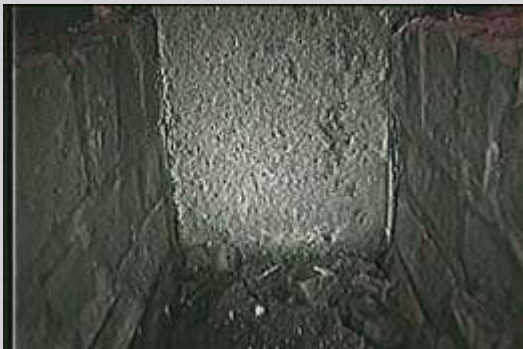
8 in. Circular Gravity Sewer Pipe Out @ 2 O'Clock

Metal plate in front of pipe.

Deposits: ☐ None ☐ Mud ☐ Sludge ☒ **Debris** ☐ Grease

Silt Depth: **1** (in.) Deposits Extent: **Light**

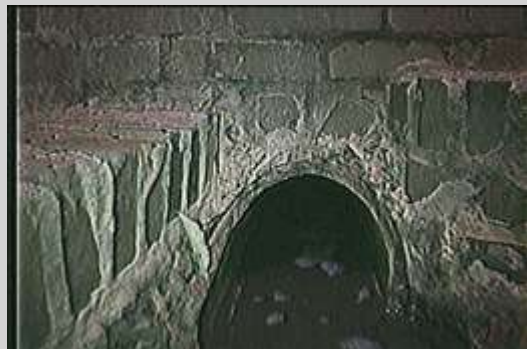
8 in. Circular Gravity Sewer

Infiltration: **Evidence**

Pipe Seal Cond: **Cracked**
